Jet grouting for the Highbury Interceptor Siphon access chamber

Paolo Gazzarrini, P.Eng.
Sea To Sky Geotech Inc., West Vancouver, BC, Canada
Andrew Port, P. Eng. and Garry Stevenson, P.Eng., P.Geo.
Klohn Crippen Berger, Vancouver, BC, Canada
Hein Steunenber, P.Eng. and Florence Ho, EIT
Metro Vancouver, Burnaby, BC, Canada

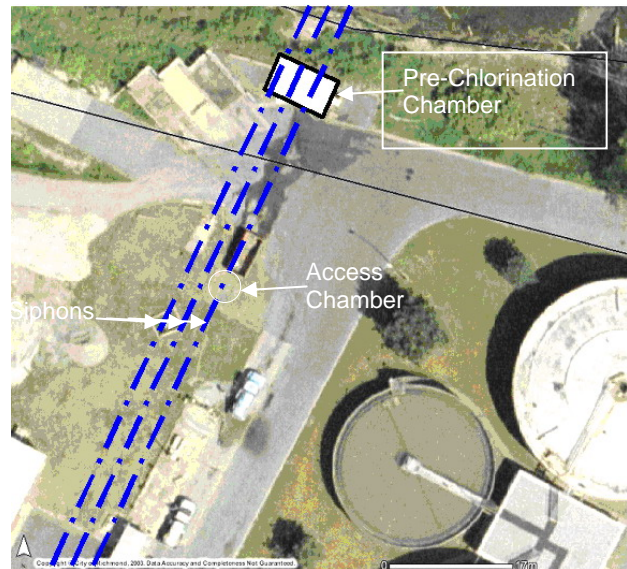
Figure 2. Site arrangement

The Highbury Interceptor Siphon, constructed in 1959, consists of a reinforced concrete structure with three conduits conveying sewage under the North Arm of the Fraser River to the south bank where it transitions into three reinforced concrete pipes leading into the Iona Waste Water Treatment Plant. Figure 1 shows the location of the project at the edge of the Fraser River delta. Figure 2 shows the site arrangement.

An open excavation was quickly dismissed. The site is crowded (see Figure 2) and daily access was required by operations personnel, adjacent to the shaft location. The risk of settlement of nearby facilities due to dewatering was very high, due to the presence of compressible silt beneath the site.

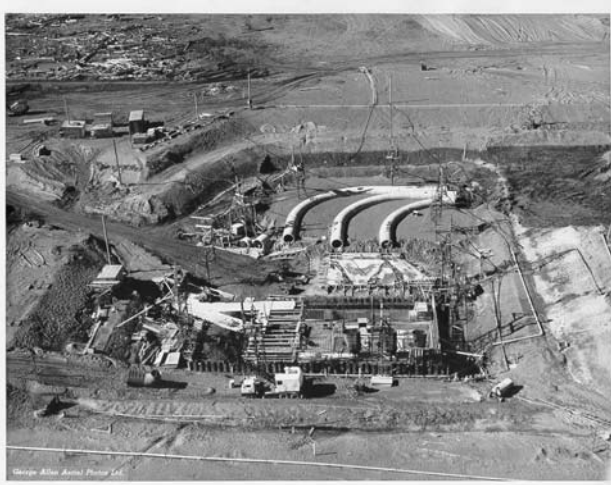
Figure 3. Aerial view of siphons during original construction

The bell-and-spigot siphon pipes have an internal diameter of 1677 mm, a wall thickness of 184 mm, and an external diameter of 2045 mm. The spacing between the pipes is approximately 500 mm, based on construction drawings and on probe holes water-jetted to locate the crowns of the pipes. At the location of the proposed access chamber, the invert of the siphon is at about El. -6 m, or 9.5 m below ground surface.

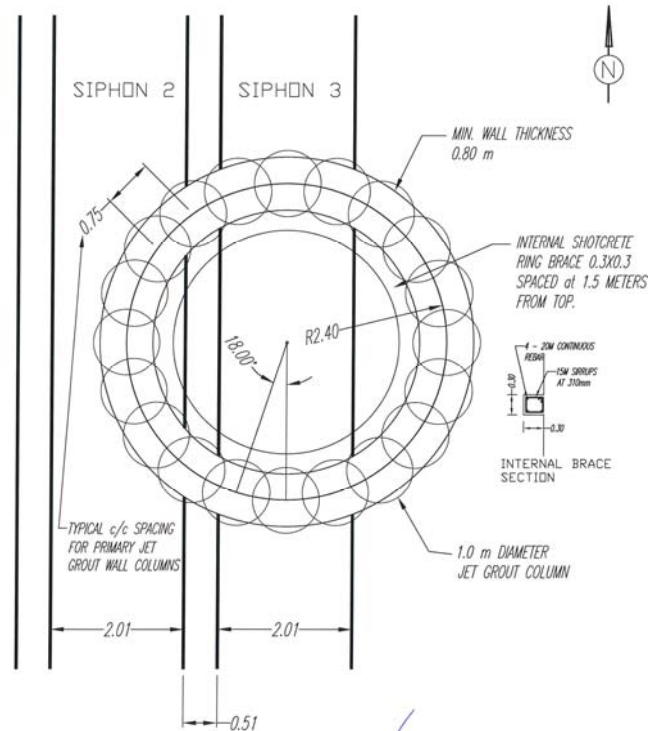
Figure 4. Plan of chamber wall columns

Metro Vancouver awarded the contract to Matcon Excavation and Shoring, which retained Geopacific Consultants Ltd. for the preparation of the detailed design. Figures 4, 5, and 6 show the final design of the jet grout columns. Matcon had completed an extensive trial installation to document its capabilities in terms of achievable column diameters in silt and sand at a site near Iona, as they were tendering for the chamber project, and this was accepted as the trial demonstration.

The main quality control was the grout mix and spoil (grout mix returned to the ground surface) density control, done with mud balance, at the grout plant and during the jetting phase. Site preparation began on June 9, 2009. Jet grouting of the 21, 1 m diameter wall columns began June 24 and was completed about 5 days later on June 29. Jet grouting of the 2.5 m diameter base slab columns began on June 29 and was completed about 6 days later on July 4, 2009.

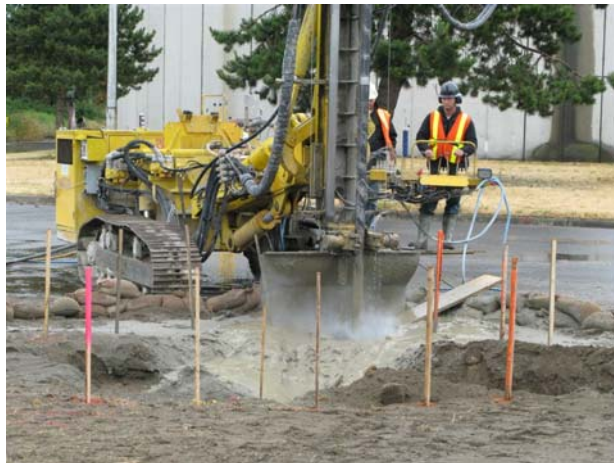
Figure 7. Drill rig excavating chamber wall column

The jet grouted columns were installed in June and July 2009. The contractor initially chose to install the wall columns with the split-space method sequence (primary, secondary, tertiary columns), followed by the bottom slab using a sequential ("fresh on fresh") sequence. One additional column, compared to the design layout, was installed. Figure 7 shows drilling for a chamber column, while Figure 8 shows the mud pit and grout plant arrangement.

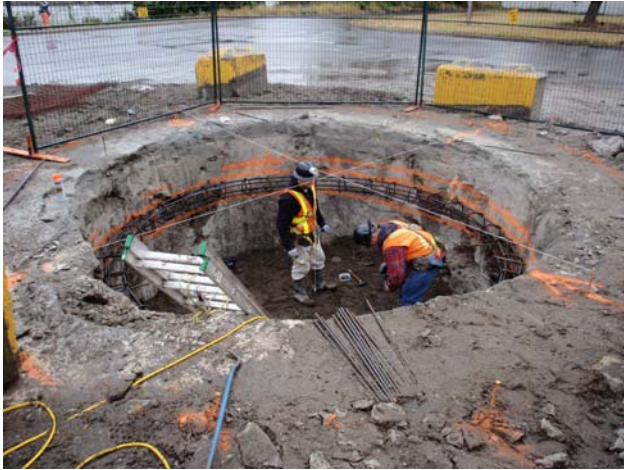
Figure 9. Shoring ring installation in upper shaft

After completion of the columns for the wall and bottom plug, the contractor started excavation inside the shaft with a conventional backhoe on about July 5, 2009. Figure 9 shows the upper shaft being prepared for the first ring of reinforced shotcrete. The first observation, during the excavation of the first few metres, was that the thickness of the wall was larger than specified; 1.1 to 1.2 m vs. 0.80 m specified minimum. The large column diameter had an impact on construction as some soil-cement had to be excavated by hand to achieve the minimum specified clearance at the siphon pipe. However, this was not an onerous undertaking due to the low compressive strength. The contractor's design called for internal bracing (reinforced shotcrete rings) every 1.5 m from the top, but considering the increased thickness of the wall and the much higher compressive strength obtained, omission of the bracing was accepted after assessment by the contractor's engineer, with the exception of the first ring immediately below the ground surface.

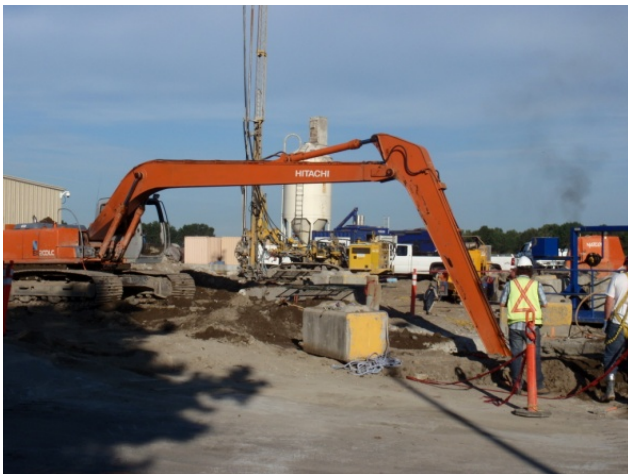
Figure 10. Excavation with long-arm backhoe

Excavation at depth was performed with a long-arm backhoe excavator and, at the bottom, with a vacuum truck. Figures 10 and 11 show early excavation and the nearly-completed chamber. The chamber columns were watertight. However, as excavation was nearing completion on about July 14, 2009 a small leakage of water occurred at the crown of the siphon, where the connection between the bottom of the jet grout wall columns and the top of the siphon pipes was not adequate to prevent the inflow of water. This was due to the fact that the jet nozzles are approximately 200 mm above the bottom of the bit; since the jet shoots horizontally and not downward, it was not able to seal adequately around the crown of the siphon pipes.

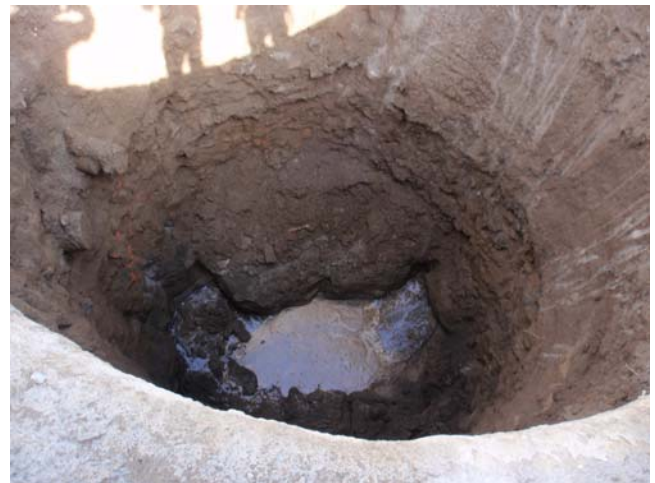
Figure 12. Missing column, left side of base

A second, more serious problem was discovered as the excavation was extended below the crown of the siphon pipe. At this time it became evident that a column was missing, as can be seen in Figure 12. Water and sand under pressure started to run in from the area of the missing column and in a few minutes the shaft was filling rapidly. The excavation was backfilled to prevent excessive piping of sand into the chamber. The Contractor initially tried to seal the area by grouting through a grout pipe drilled to the vicinity of the leak. However, it was not possible to achieve a positive seal that would withstand the water pressure.

After discussions and assurances regarding the status and position of the siphon, the obstruction was drilled, the

hole was advanced to design depth, and the missing base slab column was jetted. On July 27, 2009, about 35 days after the first column was installed, and about 22 days after excavation began, the excavation was completed. The top of the siphon was subsequently cut on August 1, 2009 with success and the lining installed on schedule. See Figures 13 and 14. Once the access chamber was sealed around the siphon, the top half of the siphon (from the crown to the springline) inside the chamber was removed over a 3 m length to provide access for the lining process. Following liner installation, a permanent manhole, constructed within the construction chamber, completed the work.
